Underwater Ordnance Survey
Fisherman's Bay (on Hog Island)
and the
Waugoshance Lighthouse

Underwater Ordnance Survey
Fisherman's Bay (on Hog Island) and the
Waugoshance Lighthouse

7 October 2005

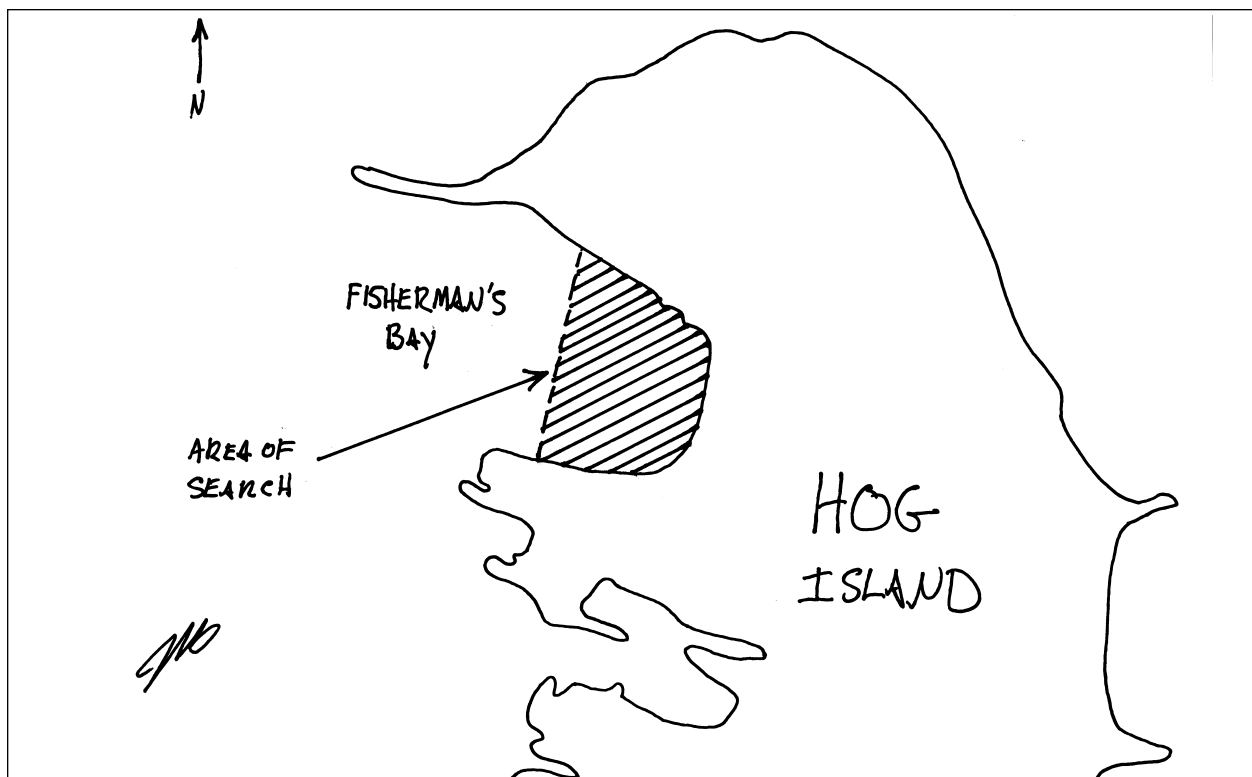
A wide area search was then begun by towing the diver behind the inflatable boat in a north/south track within the bay. Shallow depths and 10-foot visibility permitted a reasonably swift pace. Several anomalies were investigated, though none proved to be ordnance-related. Later that afternoon we headed back out to the 41 FT Coast Guard boat to transfer gear and re-stow the inflatable boat. We then returned to Coast Guard Station Charlevoix.

Area of search within Fisherman's Bay.

Since no ordnance items were detected in Fisherman's Bay, no action needs to be taken.

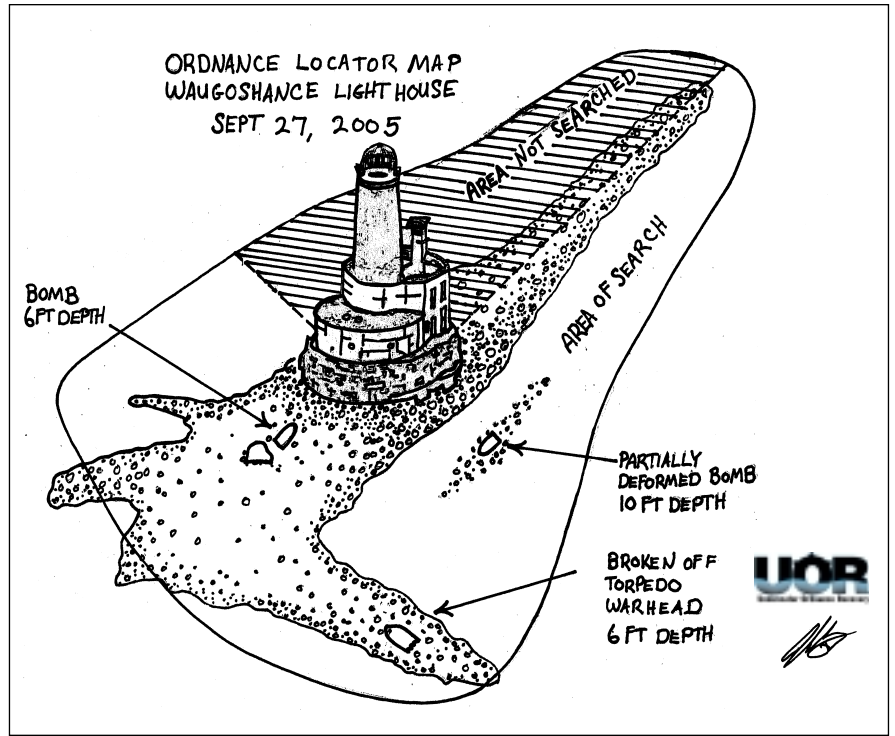
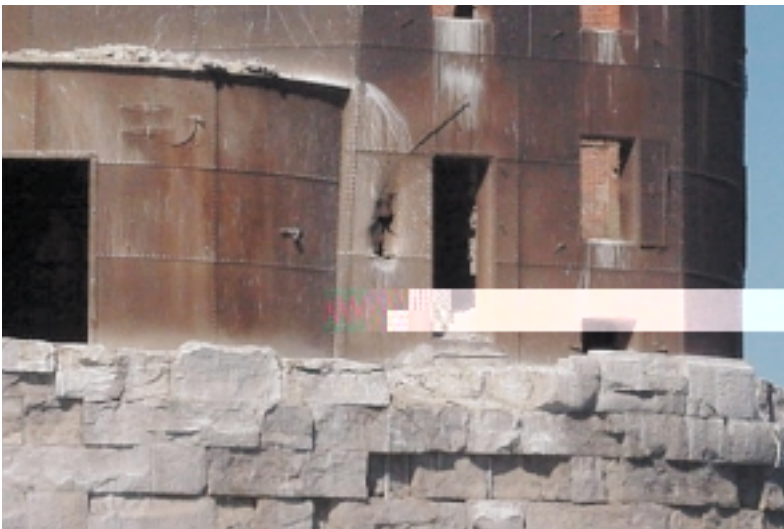
The first ordnance item found was located just off the east side of the light at a depth of 10-feet. An “old style” bomb with the nose pointing south embedded in the lake floor to almost half its diameter. An M117 750 LB bomb has a 16-inch diameter and a length of 46-inches. The dimensions of this item are 18-inches wide and 54-inches long. The dimensions recorded are a bit skewed due to the fact that the bomb was deformed on impact, having a flattened area along the top (creating a wider than normal diameter), a flattened tail (adding a few inches to its length), and a dent along the nose. The nose fuze well is hollowed out, and the base plate appears to be missing. No lifting lugs were visible. My conclusion is that this bomb is probably a M117 750 LB General Purpose Bomb.

A close look at the armor plating on the east side of the light reveals damage consistent with the size and shape of this piece of ordnance.

Inspection of the armor plating reveals an indentation about the same size as the partially deformed bomb in the water nearby.

- Request that the US Navy Explosive Ordnance Disposal Team respond and detonate the items in place, using "low order" detonation procedures. Though not always successful in preventing "high order detonation," these procedures are intended to explosively break apart ordnance and reduce the chance for a high order detonation. The remains can then be safely collected and disposed of at a more suitable location.

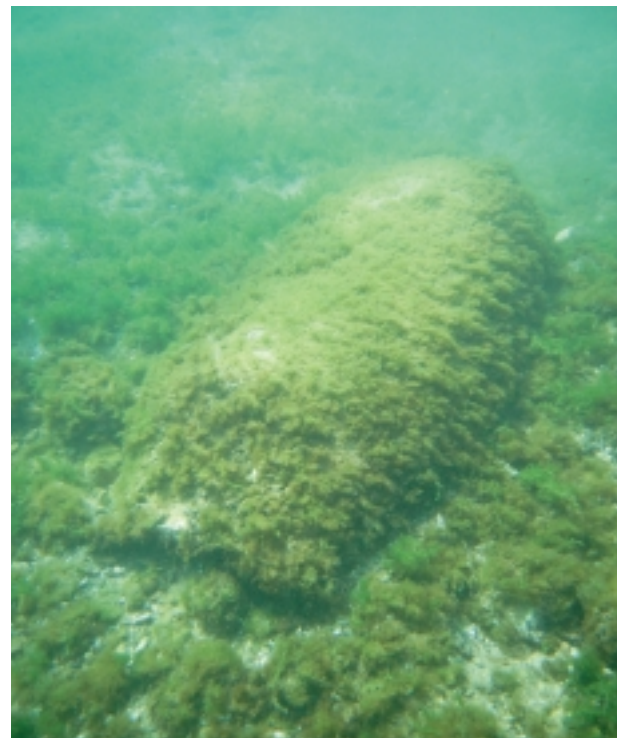
The damage from this bomb appears to have come from direct contact with the lighthouse.

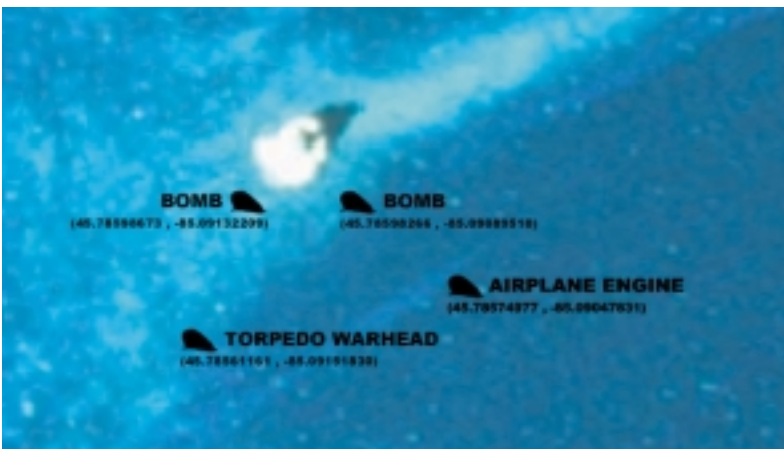
This satellite image plots the GPS location of each item as follows:

- Deformed Bomb 45.78598266, 85.09089510
- Torpedo Warhead 45.78561161, 85.09151830
- Intact Bomb 45.78598673, 85.09132209
- Airplane Engine 45.78574977, 85.09047831

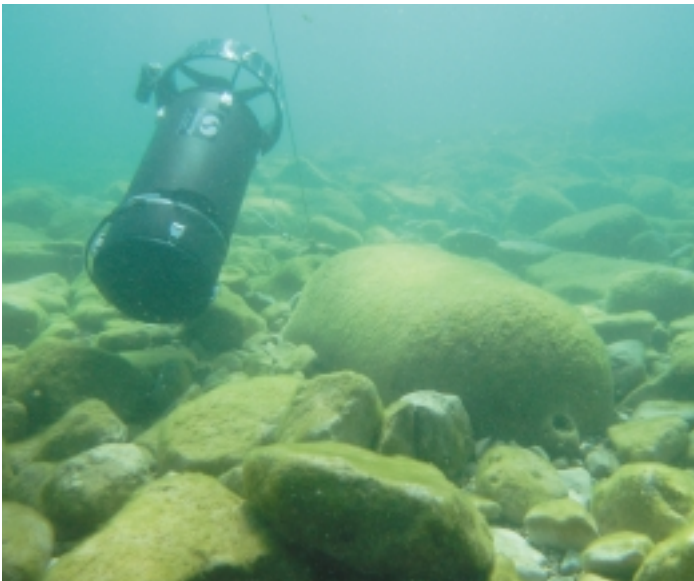
The second ordnance item was located SE of the light, in about 6-feet of water. It is a torpedo warhead, minus the propulsion unit. The body of the warhead is 22-inches in diameter and has a length of approximately 36-inches (with about a third of the diameter having settled into the bottom). The warhead faces west, is constructed of ferrous metal and appears undamaged near the nose. Where the propulsion unit would have been attached, there is evidence of a violent separation, possibly resulting from an aerial deployment having glanced off a shallow rock or the lighthouse itself. No exploder or arming well is visible.

The nose of this torpedo appears undamaged.

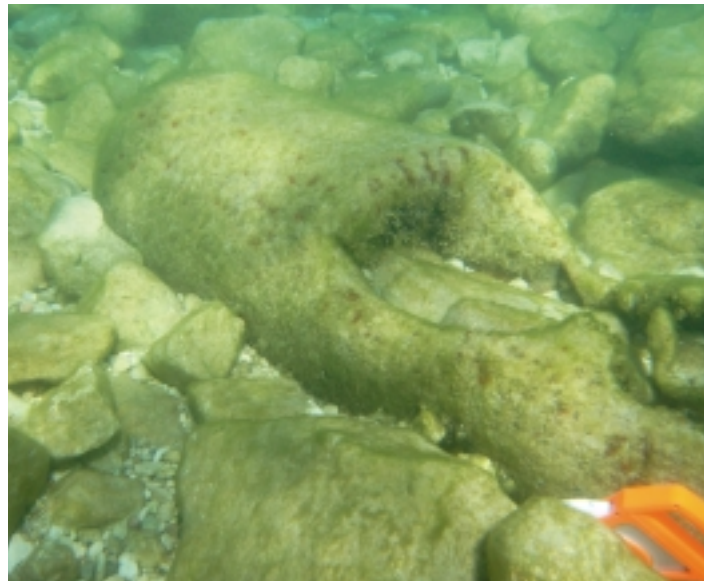
- It must be assumed these items are explosive-filled, armed, and dangerous, since it is difficult to positively determine otherwise. The torpedo warhead and one of the bombs have sustained sufficient damage to have exposed the explosive filler material to lake waters, thereby greatly reducing the potential for a high order detonation.

The rear area of the warhead shows how it was violently separated from the propulsion unit.

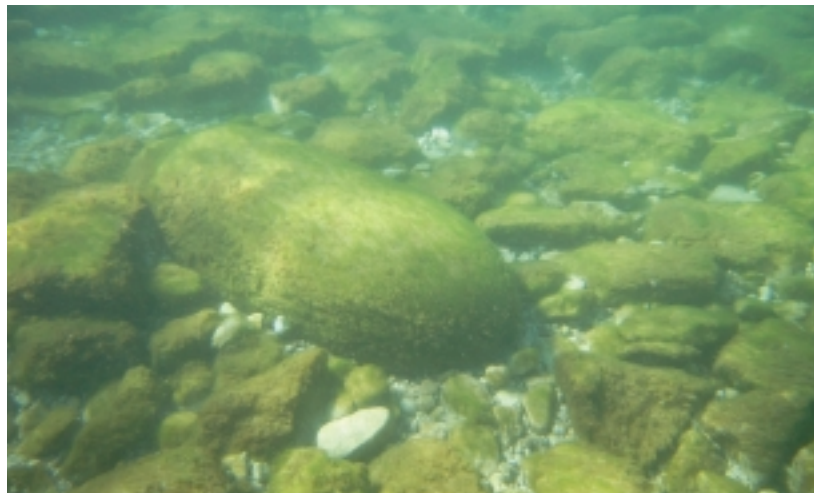
The third ordnance item found was located almost due south of the light in about 6-feet of water. Relatively close to the light and near an unusually large boulder, it points north. Another old style bomb, it has dimensions similar to the first bomb located. Exact measurements could not be taken due to the surge created by high waves breaking over the area. This bomb appears intact and undamaged and has no cavities in either fuze well. No lifting lugs were visible, and the bomb case appears to have settled in to the bottom to almost half its diameter.

This bomb appears intact and without damage.

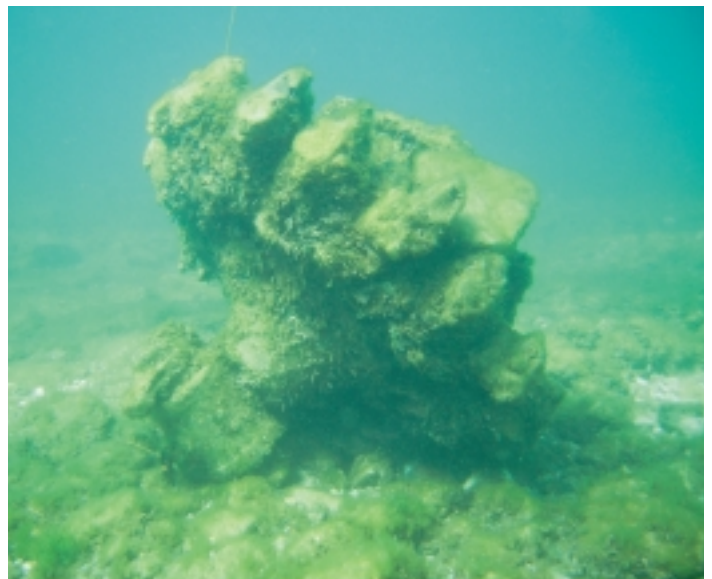
Found resting nearby is this early aircraft engine; note that it once had a two blade wood propeller.
